# **Smoke and Dye Testing Summary**

### **High Level Sewershed**

Run Summary ————————————————————————————————————								
Test ID	Test Type	Date Inspected	Company / Super.	Blower MH	Ground Condition	Notification Made?	Total Length	
S1028-062	Smoke	9/8/2008	ADS/TM	S15CC1023MH	Dry	Yes	829.20

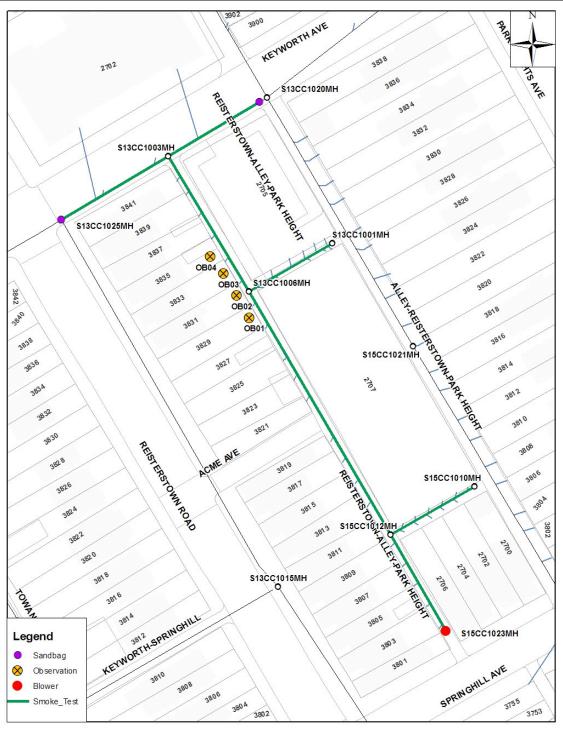
**Picture** \S1028-062-OB01-P01.jpg

**Comments** Smoke from cleanout in back yard, 10 ft. from

alley. 3829 Reisterstown Rd

**Comments** Back of house, 3829

Reisterstown Rd
